# Manhole Inspection Summary

Manhole # S09II1014MH

**Location** Address: **3617 WOODLAND AVE** Cross Street: **REISTERSTOWN RD**

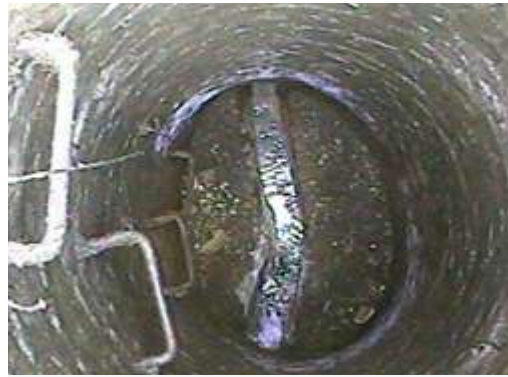
Top View

DEBRIS ON BENCH

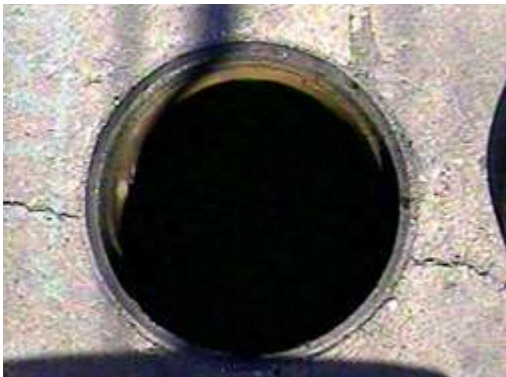
Top View

**Frame** Offset: **1** (in.) Condition: ☒ Sound ☐ Cracked ☐ Leaks

OFFSET FRAME

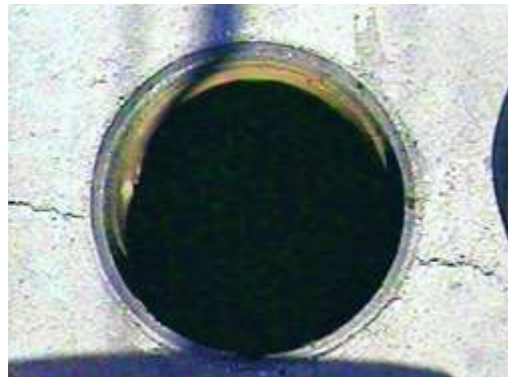
Defect 2

OFFSET FRAME

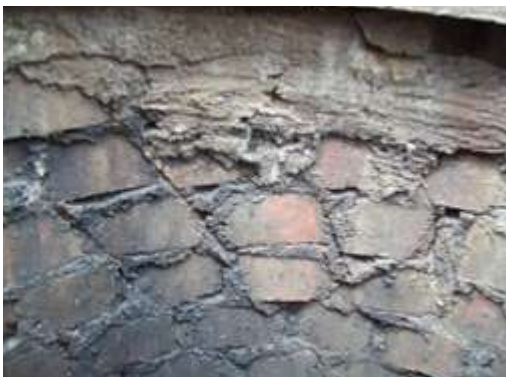
Defect 1

Condition: ☐ Sound ☒ **Cracked** ☐ Root Intrusion ☐ Loose Brick ☐ Deteriorated

CRACKED CHIMNEY

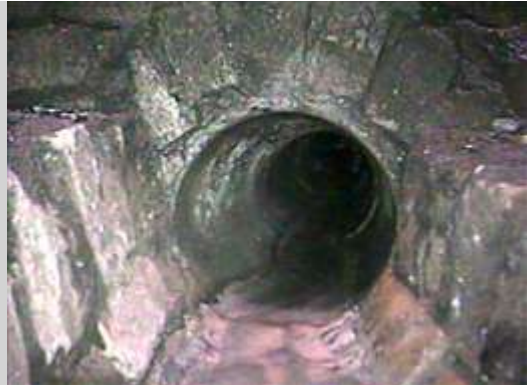
12 O'Clock Outflow

8 in. Circular Gravity Sewer  
Pipe Out @ 12 O'Clock

Pipe Height: (in.) Direct  
Pipe Material: **Clay** ☐ Pipe Lined  
Invert Depth: **9.80** (ft.) Flow Characteristics: **Slow**  
Deposits: ☒ None ☐ Mud ☐ ~~Gravy~~ ☐ Debris ☐ Grease  
Silt Depth: (in.) Deposits Extent:  
Infiltration: **None** Pipe Seal Cond: **Sound**

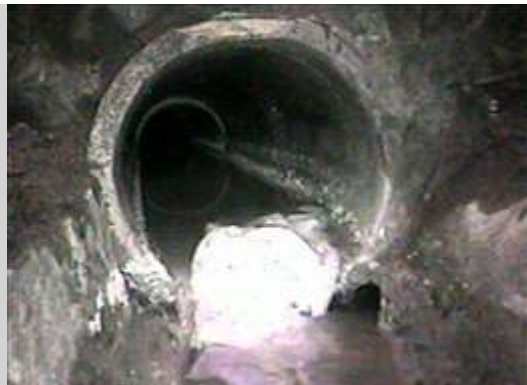
7 O'Clock Inflow

8 in. Circular Gravity Sewer  
Pipe In @ 7 O'Clock

Pipe Height: (in.) Direct  
Pipe Material: **Clay** ☐ Pipe Lined  
Invert Depth: **9.75** (ft.) Flow Characteristics: **Slow**  
Deposits: ☐ None ☐ Mud ☒ ~~Gravy~~ ☒ Debris ☐ Grease  
Silt Depth: **0** (in.) Deposits Extent: **Light**  
Infiltration: **None** Pipe Seal Cond: **Sound**
